Subject: **Information against Containment for MET turbocharger**

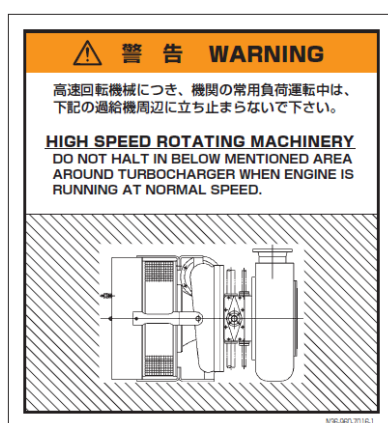
(MET-SR/SRII Series)

Fig.1 Warning label
